Class III restoration

Procedure/Study by

Dr. Giuseppe Chiodera, Brescia – Italy

Unica
anterior

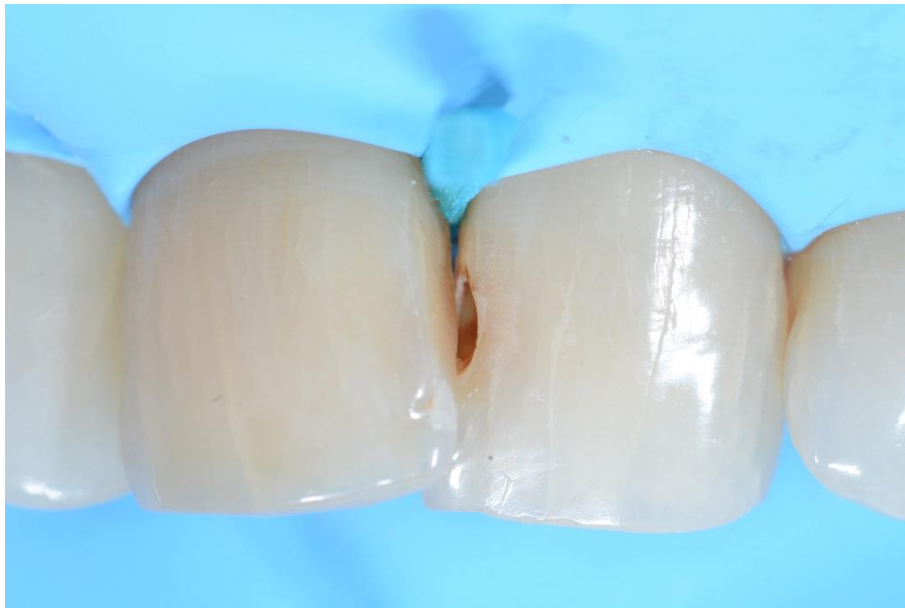
01

Pre-operative view of incisors 11 and 21 evidencing the class III carious lesion on #21, mesial. Pre-wedging was performed to allow for a simpler matrix positioning.

The patient came to our attention for a regular check. A first analysis revealed a class III carious lesion on incisor 21. We decided to eliminate the carious lesion and proceed with a direct composite restoration of the cavity.

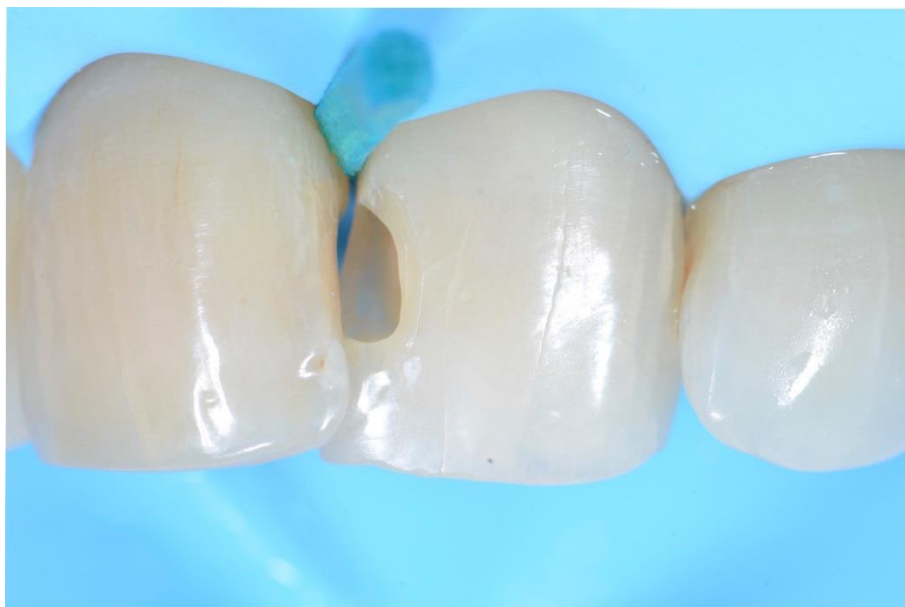
02

The clinical situation after removal of the carious lesion and cleaning of the proximal area

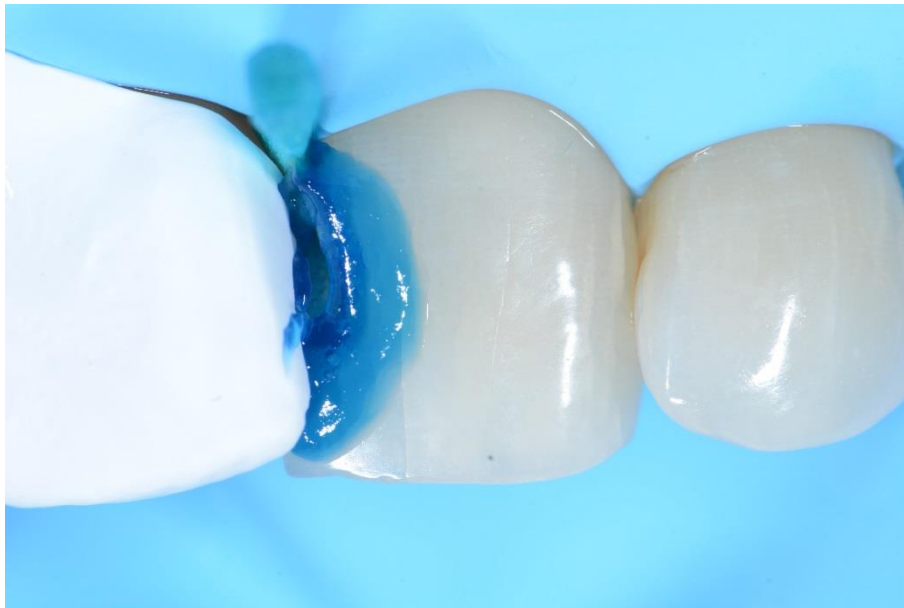
03

Etching of the cavity: it is a good practice to protect the adjacent teeth using Teflon tape

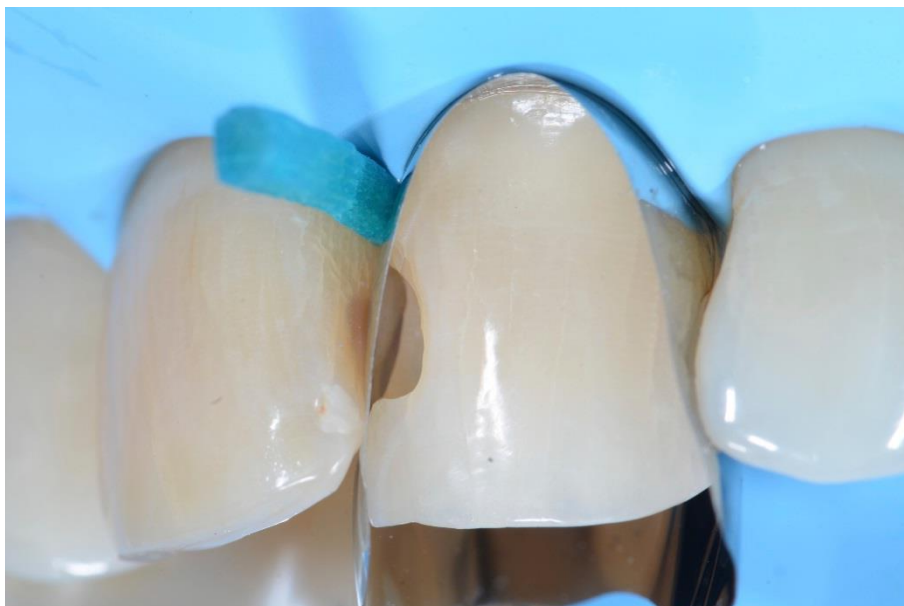
04

Unica anterior matrix placed on incisor 21 and fixed in place using a wooden wedge. The contoured shape of the matrix embraces the teeth and help the practitioner to better see where the proximal edge will be placed

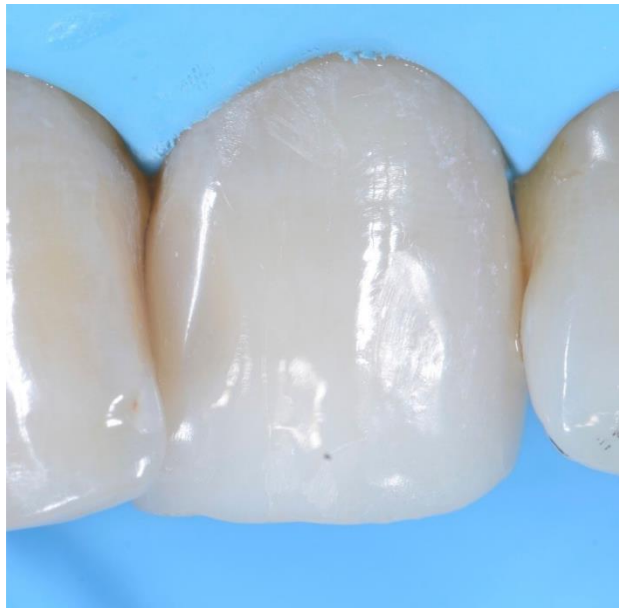
05

Incisor 21 after filling the cavity with composite.

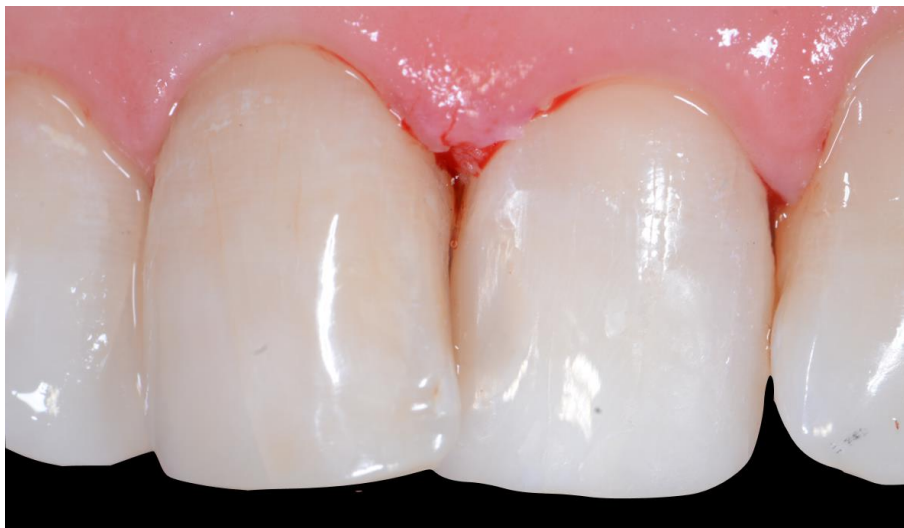
06

Immediate post-operative image after finishing and polishing. The contoured proximal walls of the matrix ensure an accurate proximal morphology with minimal finishing.

Unica anterior powered by Style Italiano is a powerful tool for direct composite anterior restorations. Thanks to its contoured shape, Unica adapts correctly to the different morphologies of anterior teeth and makes it possible to restore interproximal margins, even in case of extended Class III cavities where the tooth profile is missing.
